OPERATION PLUMBBOB

Project 3.3

EVALUATION OF BURIED CORRUGATED-STEEL ARCH
STRUCTURES AND ASSOCIATED COMPONENTS

OPERATION PLUMBBO3—PROJECT 3.3

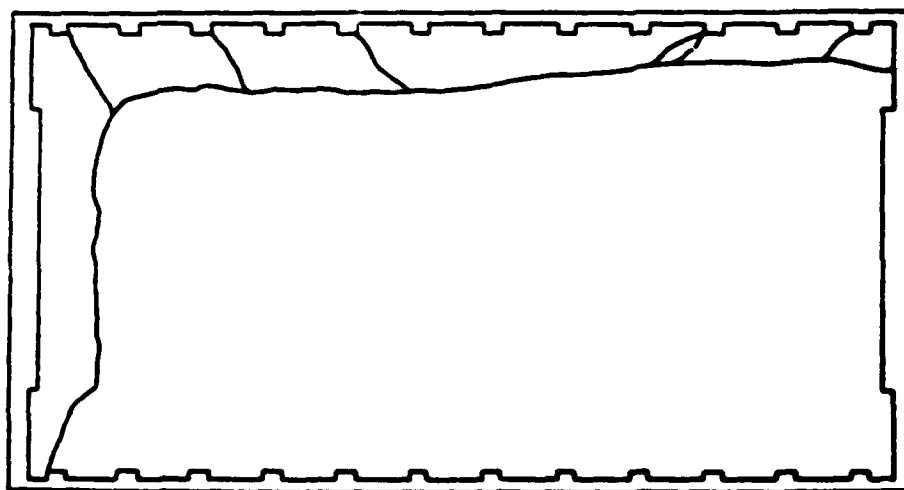
Only in Structure 3.3a was cracking of the floor evident. A sketch of the crack pattern is shown in Figure 2.38.

Figure 2.38 Crack pattern of floor, Structure 3.3a.
